**Flood Control Project Maintenance
Levee Inspections**

Fall 2016 Levee Maintenance Deficiency Summary Report

Reclamation District No. 2068 Yolano

Levee Inspection Report By Mile - Fall 2016

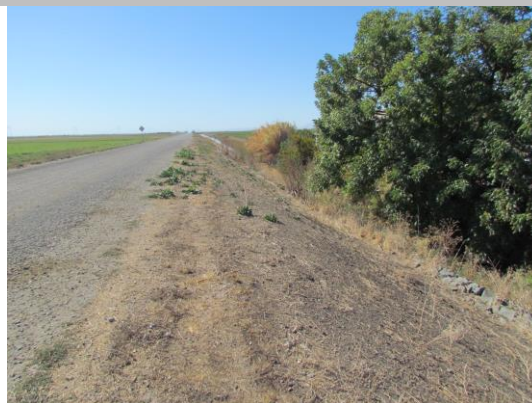
Photo 1 of 1 : FA_2016_RD2068_193_9_20160926_00002.jpg

LM Start	0.51	Rating **	A	Issue No.	9
LM End	5.48	Issue Type +	Ma	Location *	LS
Category	Earthen Levee			GPS Latitude/Longitude	
				Start	End
Item	Vegetation			38.401232 °	38.329090 °
				-121.693800 °	-121.694065 °
DWR ID	DWR_RD2068_01_f_2016_9				
Comment Code					
V1 : Control annual grass and weeds on the levee slopes and easements.					
Inspector Comment					
No unwanted vegetation on the landside levee slope from levee mile 0.51 -5.48.

Looking downstream from the landside levee slope.

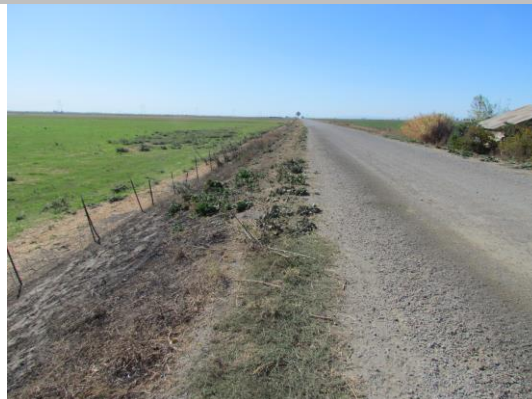
Photo 1 of 1 : FA_2016_RD2068_193_10_20160926_00001.jpg

LM Start	0.51	Rating **	A	Issue No.	10
LM End	5.48	Issue Type +	Ma	Location *	WS
Category	Earthen Levee			GPS Latitude/Longitude	
				Start	End
Item	Vegetation			38.401232 °	38.329090 °
				-121.693800 °	-121.694065 °
DWR ID	DWR_RD2068_01_f_2016_10				
Comment Code					
V1 : Control annual grass and weeds on the levee slopes and easements.					
Inspector Comment					
No unwanted vegetation on the waterside levee slope.

RD 2068 Looking downstream from the waterside levee slope.

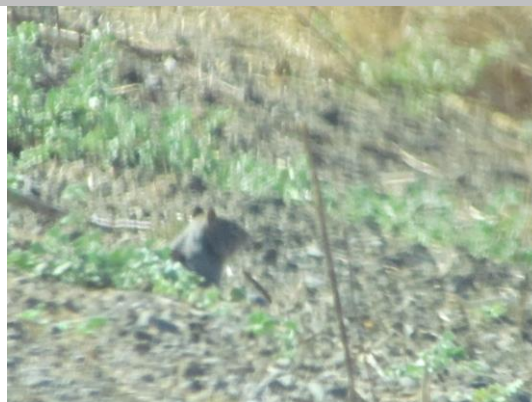
Photo 1 of 2 : FA_2016_RD2068_193_11_20160926_00003.jpg

LM Start	2.11	Rating **	M	Issue No.	11
LM End	2.46	Issue Type +	Ma	Location *	LS
Category	Earthen Levee			GPS Latitude/Longitude	
				Start	End
Item	Animal Control			38.378028 °	38.372862 °
				-121.693908 °	-121.693978 °
DWR ID	DWR_RD2068_01_f_2016_11				
Comment Code					
A1 : Exterminate rodents and backfill and compact or grout burrows.					
Inspector Comment					
There are active rodents in the area, several holes were seen but no bait stations observed on the slope where rodents were noted.

RD 2068 looking downstream landside slope from levee miles 2.11 -2.46.

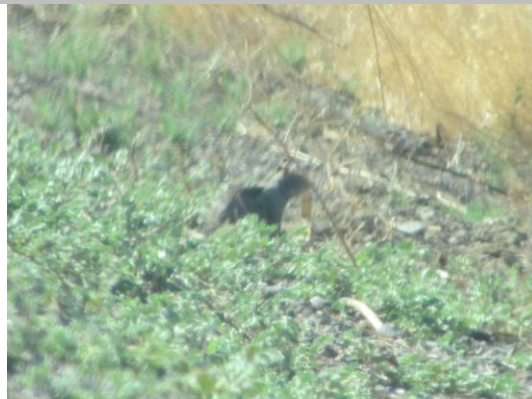
Photo 2 of 2 : FA_2016_RD2068_193_11_20160926_00004.jpg

LM Start	2.11	Rating **	M	Issue No.	11 (cont)	
LM End	2.46	Issue Type +	Ma	Location *	LS	
Category	Earthen Levee			GPS Latitude/Longitude		
				Start		End
Item	Animal Control			38.378028 °		38.372862 °
				-121.693908 °		-121.693978 °
DWR ID	DWR_RD2068_01_f_2016_11					
Comment Code						
A1 : Exterminate rodents and backfill and compact or grout burrows.						
Inspector Comment						
There are active rodents in the area, several holes were seen but no bait stations observed on the slope where rodents were noted.

RD 2068 looking downstream landside slope from levee miles 2.11-2.46.

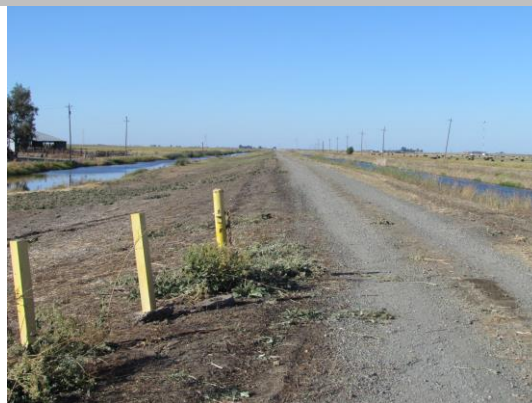
Photo 1 of 1 : FA_2016_RD2068_194_11_20160926_00007.jpg

LM Start	0.01	Rating **	A	Issue No.	11
LM End	2.73	Issue Type +	Ma	Location *	WS
Category	Earthen Levee			GPS Latitude/Longitude	
				Start	End
Item	Vegetation			38.358232 °	38.392895 °
				-121.740370 °	-121.720985 °
DWR ID	DWR_RD2068_02_f_2016_11				
Comment Code					
V1 : Control annual grass and weeds on the levee slopes and easements.					
Inspector Comment					
there is no unwanted vegetation along the waterside levee slope 0.01-2.73. The Maintaining Agency recently mowed the site.

RD 2068 looking downstream from levee mile 0.01-2.73.

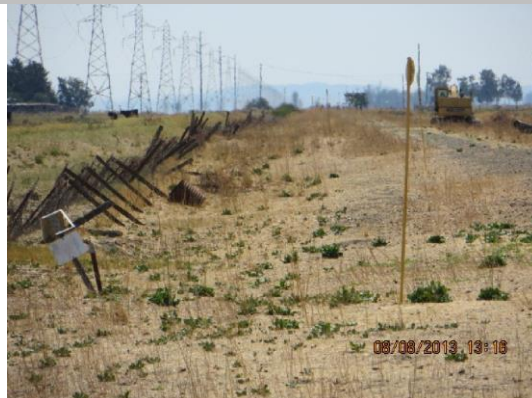
Photo 1 of 2 : UCIP_FA_2016_17531_29641.jpg

LM Start	0.91	Rating **	M	Issue No.	15
LM End	0.91	Issue Type +	En	Location *	WS
Category	Supplemental			GPS Latitude/Longitude	
				Start	End
Item	DWR UCIP Field Study			38.371273°	38.371273°
				-121.740138°	-121.740138°
DWR ID					
Comment Code					
Inspector Comment					
FS_ID:17531 DS_ID:19355 EP_NO: 8151 Repair Type: Non-Urgent Crossing Status: Indicator Found UCIP Comments: Appears abandoned. Need to verify with pipeline owner. FIELD_STRUCT_DESC: 8-inch steel gas pipe through the levee 3 feet below the crown (Permit No. 8151, 1972). Gasline markers visible on east toe of levee at intersection of levee and Delhi road. FS Date: 8/8/2013

Gasline markers next to old rail road grade, looking south.

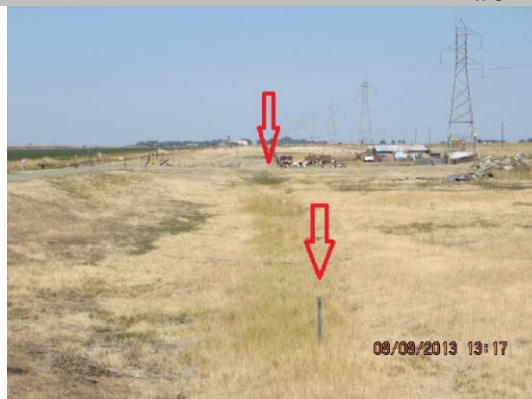
Photo 2 of 2 : UCIP_FA_2016_17531_29640.jpg

LM Start	0.91	Rating **	M	Issue No.	15 (cont)	
LM End	0.91	Issue Type +	En	Location *	WS	
Category	Supplemental			GPS Latitude/Longitude		
				Start	End	
Item	DWR UCIP Field Study			38.371273°	38.371273°	
				-121.740138°	-121.740138°	
DWR ID						
Comment Code						
Inspector Comment						
FS_ID:17531 DS_ID:19355 EP_NO: 8151 Repair Type: Non-Urgent Crossing Status: Indicator Found UCIP Comments: Appears abandoned. Need to verify with pipeline owner. FIELD_STRUCT_DESC: 8-inch steel gas pipe through the levee 3 feet below the crown (Permit No. 8151, 1972). Gasline markers visible on east toe of levee at intersection of levee and Delhi road. FS Date: 8/8/2013

Gasline markers on east side of levee toe looking North.

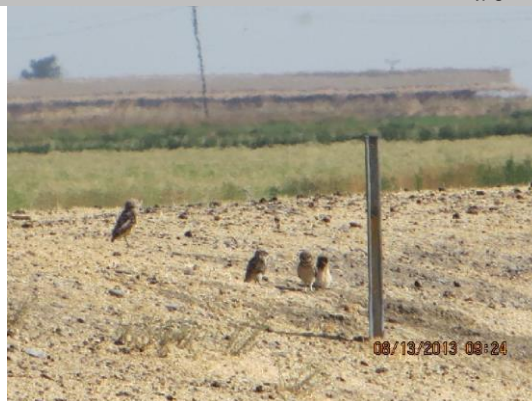
Photo 1 of 2 : UCIP_FA_2016_17532_29644.jpg

LM Start	1.07	Rating **	M	Issue No.	16
LM End	1.07	Issue Type +	En	Location *	WS
Category	Supplemental			GPS Latitude/Longitude	
				Start	End
Item	DWR UCIP Field Study			38.373330 °	38.373330 °
				-121.738530 °	-121.738530 °
DWR ID					
Comment Code					
Inspector Comment					
FS_ID:17532					
DS_ID:19354					
EP_NO: 13028					
Repair Type: Non-Urgent					
Crossing Status: Indicator Found					
UCIP Comments: Need improved signage on LS and WS shoulders.					
FIELD_STRUCT_DESC: 10-inch steel pipe through the levee 2 feet below the crown. A 4-inch gas line is sleeved through the 10-inch pipe.					
Sign missing from marker post on east slope. 2-inch vent pipe with identification sign located off west bank of levee and off toe of east side of levee at fence (Permit No. 13028, 1981).					
FS Date: 8/13/2013

Sign post without markings on WS slope.

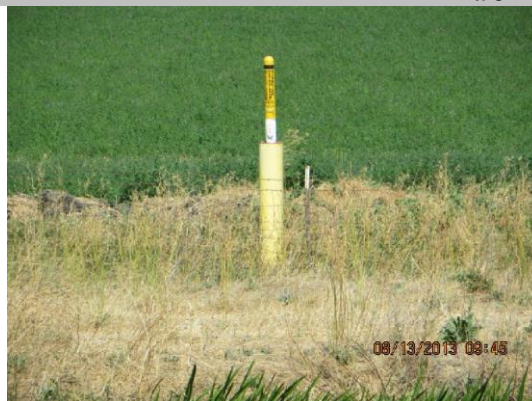
Photo 2 of 2 : UCIP_FA_2016_17532_29643.jpg

LM Start	1.07	Rating **	M	Issue No.	16 (cont)
LM End	1.07	Issue Type +	En	Location *	WS
Category	Supplemental			GPS Latitude/Longitude	
				Start	End
Item	DWR UCIP Field Study			38.373330 °	38.373330 °
				-121.738530 °	-121.738530 °
DWR ID					
Comment Code					
Inspector Comment					
FS_ID:17532					
DS_ID:19354					
EP_NO: 13028					
Repair Type: Non-Urgent					
Crossing Status: Indicator Found					
UCIP Comments: Need improved signage on LS and WS shoulders.					
FIELD_STRUCT_DESC: 10-inch steel pipe through the levee 2 feet below the crown. A 4-inch gas line is sleeved through the 10-inch pipe.					
Sign missing from marker post on east slope. 2-inch vent pipe with identification sign located off west bank of levee and off toe of east side of levee at fence (Permit No. 13028, 1981).					
FS Date: 8/13/2013

Sign marker off LS toe.

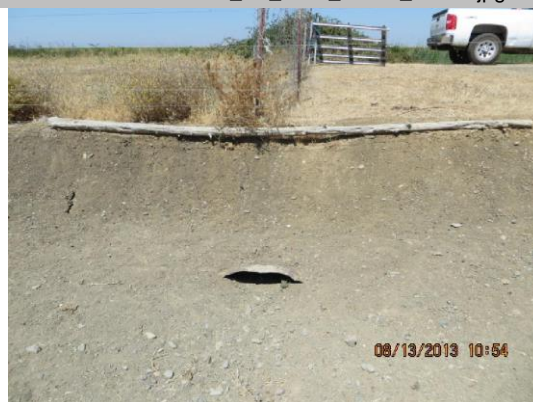
Photo 1 of 1 : UCIP_FA_2016_42725_29680.jpg

LM Start	3.15	Rating **	M	Issue No.	21
LM End	3.15	Issue Type +	En	Location *	CR
Category	Supplemental			GPS Latitude/Longitude	
				Start	End
Item	DWR UCIP Field Study			38.397933 °	38.397933 °
				-121.716406 °	-121.716406 °
DWR ID					
Comment Code					
Inspector Comment					
FS_ID:42725 DS_ID:19352 EP_NO: 10164 Repair Type: Non-Urgent Crossing Status: Found UCIP Comments: Appears abandoned and if so should be done properly. Pipe burried except for small opening. FIELD_STRUCT_DESC: *ABANDONED* 6 of 6: 48-inch corrugated metal pipe through the levee 4.0 feet below the crown (ABO No. 10164, 1974). Originally included in the O&M manual, 1962. FS Date: 8/13/2013

Pipe buried but visible at toe of east side of levee.
